Contents

1 Diagnostic Message Description

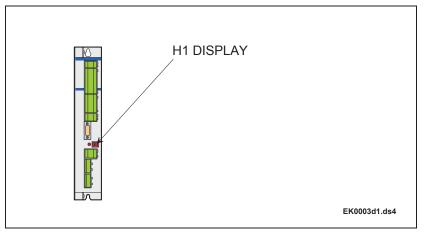
Fig. 1-2: H1-Display

The H1 condition display on the front side of the DKC gives information about:

- · Operating condition of the drive controller
- Drive controller or cable malfunctions
- Motor malfunctions
- · Malfunctions caused by invalid parameter input
- Application errors

The symoblized diagnostic number appears on this two positional-seven segment display. The form of the display is seen on the diagram "Priority dependent diagnostic message diagram."

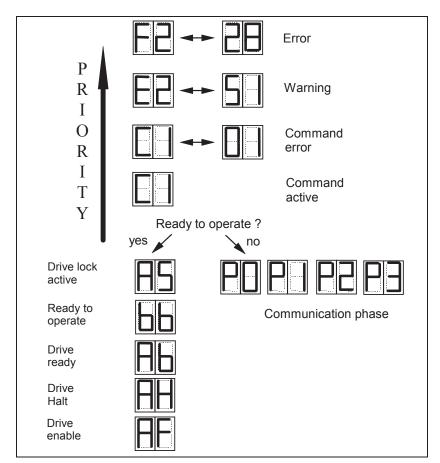
Fig. 1-3: Priority dependent diagnostic message diagram

If more than one diagnostic message is generated at the same point within the string, the diagnostic with the highest priority will be displayed first.

The following graphic shows the order of priority.

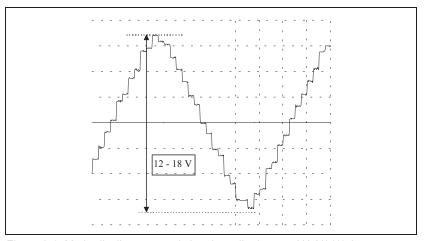
Figure 2-1: Methodically measured signal amplitude over AK: X31/1-2

F822 Motor Encoder Failure: Signal too Small

- Defective feedback cable.
- Defective feedback.

This error can only be cleared in parametrization mode (phase 2). As a result of this error, the encoder emulation is switched off.
